# Single Survey

<b>Property Address</b>	17 Sunnyside Court Portlethen Aberdeen AB12 4LY
<b>Customer</b>	Mrs A Witter
<b>Date of Inspection</b>	02/02/2026
<b>Prepared by</b>	Kenneth J Silver Harvey Donaldson & Gibson Chartered Surveyors

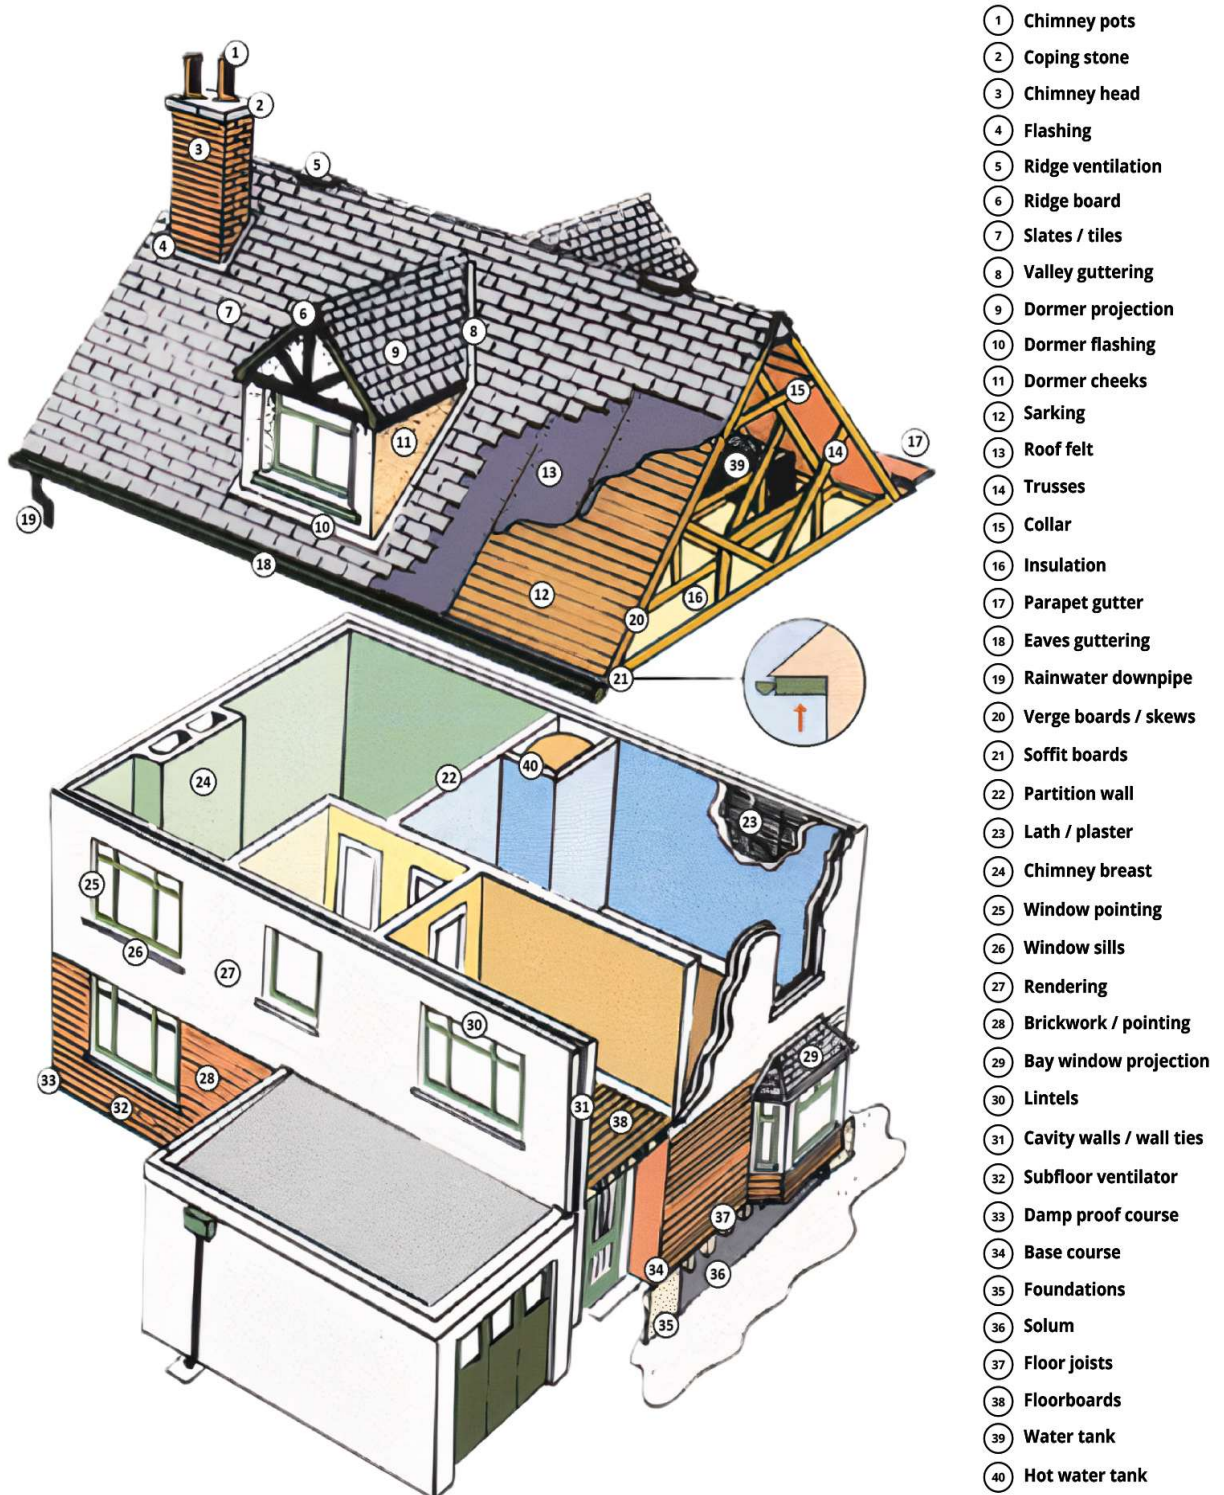
## Sectional Diagram showing elements of a typical house

Reference may be made in this report to some or all of the above component parts of the property. This diagram may assist you in locating and understanding these items.
