Single Survey

survey report on:

Property address	Flat E, 10 Hosefield Road, Aberdeen, AB15 5NB
Customer	Mr S Murray
Customer address	Flat E, 10 Hosefield Road, Aberdeen, AB15 5NB
Prepared by	Allied Surveyors Scotland Ltd
Date of inspection	6th January 2025

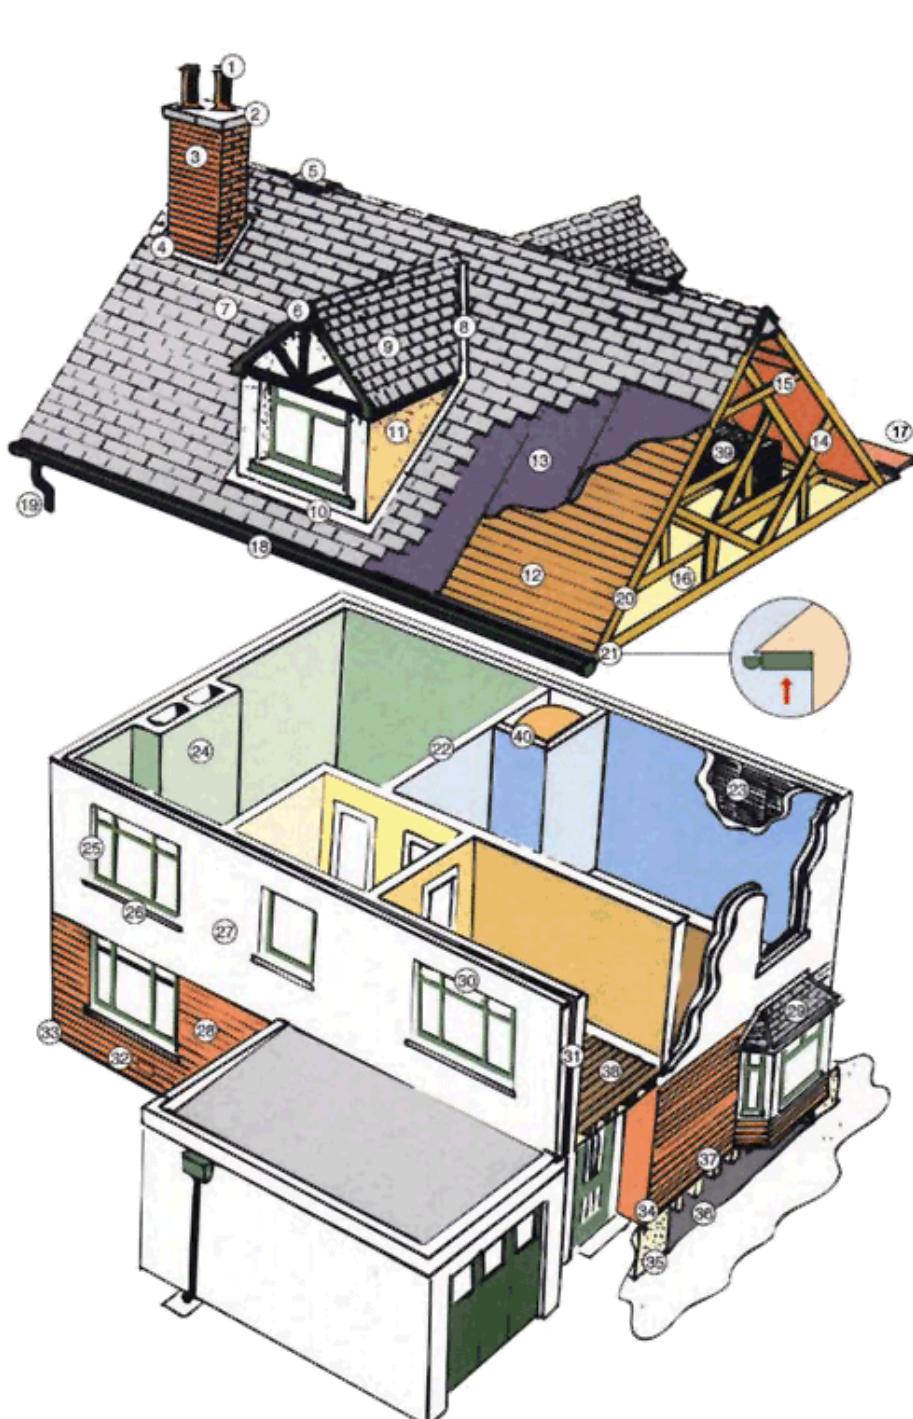
Sectional Diagram showing elements of a typical house

- 1 Chimney pots
- 2 Coping stone
- 3 Chimney head
- 4 Flashing
- 5 Ridge ventilation
- 6 Ridge board
- 7 Slates / tiles
- 8 Valley guttering
- 9 Dormer projection
- 10 Dormer flashing
- 11 Dormer cheeks
- 12 Sarking
- 13 Roof felt
- 14 Trusses
- 15 Collar
- 16 Insulation
- 17 Parapet gutter
- 18 Eaves guttering
- 19 Rainwater downpipe
- 20 Verge boards /skews
- 21 Soffit boards
- 22 Partition wall
- 23 Lath / plaster
- 24 Chimney breast
- 25 Window pointing
- 26 Window sills
- 27 Rendering
- 28 Brickwork / pointing
- 29 Bay window projection
- 30 Lintels
- 31 Cavity walls / wall ties
- 32 Subfloor ventilator
- 33 Damp proof course
- 34 Base course
- 35 Foundations
- 36 Solum
- 37 Floor joists
- 38 Floorboards
- 39 Water tank
- 40 Hot water tank

Reference may be made in this report to some or all of the above component parts of the property. This diagram may assist you in locating and understanding these items.
