# Single Survey

<b>Property address</b>	25 Millbank View, Grandholm Crescent, Aberdeen, AB22 8BE
<b>Customer</b>	Mr & Mrs M Kelman
<b>Customer address</b>	Flat 25, Millbank View, Grandholm Crescent, Bridge Of Don, Aberdeen, AB22 8BE
<b>Prepared by</b>	Allied Surveyors Scotland Ltd
<b>Date of inspection</b>	22nd January 2026

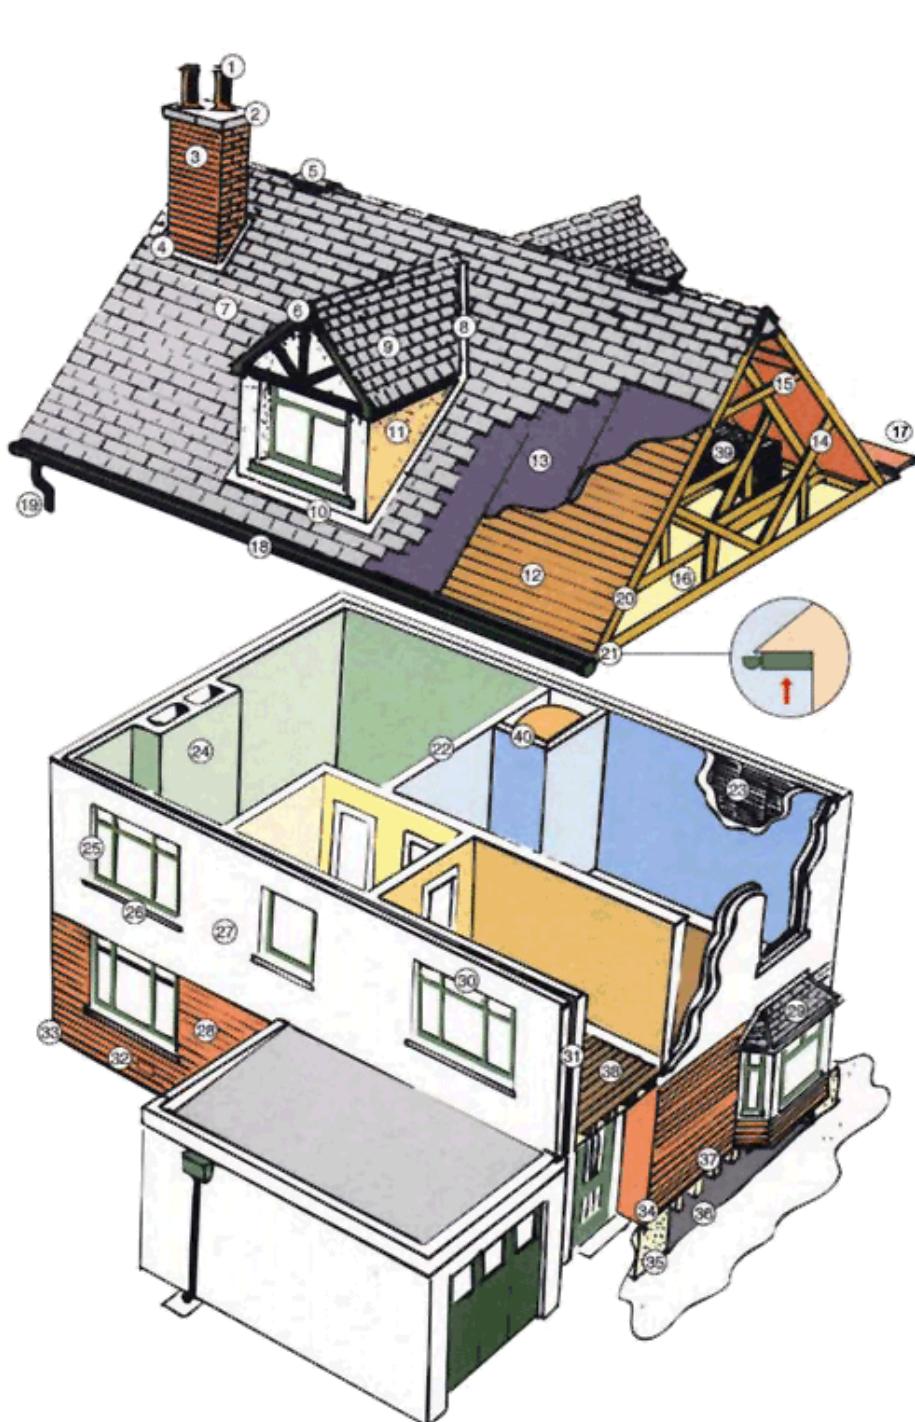
## Sectional Diagram showing elements of a typical house

- 1 Chimney pots
- 2 Coping stone
- 3 Chimney head
- 4 Flashing
- 5 Ridge ventilation
- 6 Ridge board
- 7 Slates / tiles
- 8 Valley guttering
- 9 Dormer projection
- 10 Dormer flashing
- 11 Dormer cheeks
- 12 Sarking
- 13 Roof felt
- 14 Trusses
- 15 Collar
- 16 Insulation
- 17 Parapet gutter
- 18 Eaves guttering
- 19 Rainwater downpipe
- 20 Verge boards /skews
- 21 Soffit boards
- 22 Partition wall
- 23 Lath / plaster
- 24 Chimney breast
- 25 Window pointing
- 26 Window sills
- 27 Rendering
- 28 Brickwork / pointing
- 29 Bay window projection
- 30 Lintels
- 31 Cavity walls / wall ties
- 32 Subfloor ventilator
- 33 Damp proof course
- 34 Base course
- 35 Foundations
- 36 Solum
- 37 Floor joists
- 38 Floorboards
- 39 Water tank
- 40 Hot water tank

Reference may be made in this report to some or all of the above component parts of the property. This diagram may assist you in locating and understanding these items.
