Home Report

Scottish Single Survey

Single Survey

Property address	Millview Scotsmill Banff AB45 2TD
Customer	Peter Smith & Nigel Smith
Customer address	Millview Scotsmill Banff AB45 2TD
Prepared by	Shepherd Chartered Surveyors
Date of inspection	22/04/2026

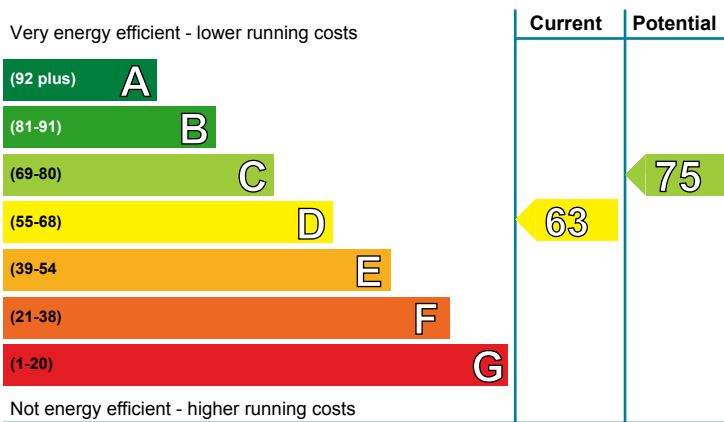
Energy Efficiency Rating

This graph shows the current efficiency of your home, taking into account both energy efficiency and fuel costs. The higher this rating, the lower your fuel bills are likely to be.

Your current rating is **band D (63)**. The average rating for EPCs in Scotland is **band D (61)**.

The potential rating shows the effect of undertaking all of the improvement measures listed within your recommendations report.

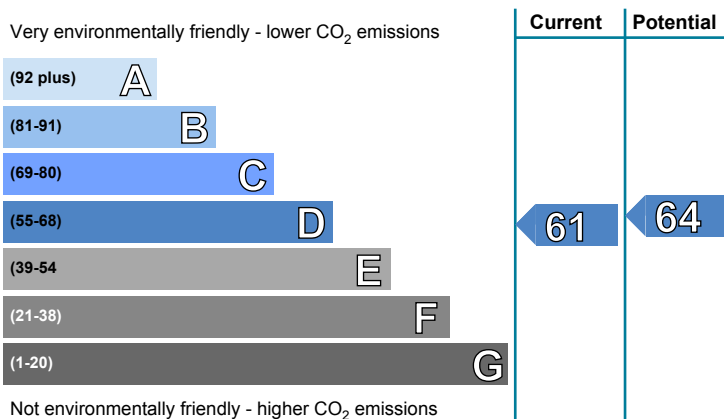
Environmental Impact (CO₂) Rating

This graph shows the effect of your home on the environment in terms of carbon dioxide (CO₂) emissions. The higher the rating, the less impact it has on the environment.
