Castlebrae,
Aberchirder,
Huntly,
Aberdeenshire,
AB54 7PU

Home Report

Single Survey

Property Address	Castlebrae, Aberchirder, Huntly, Aberdeenshire, AB54 7PU
Reference	1316533
Customer Name	Brian Greig
Date of Inspection	14th November 2025
Surveyor's name, qualifications and office	Blair Stephen AssocRICS DM Hall LLP Chartered Surveyors 64 Market Place Inverurie AB51 3XN Tel: 01467 624393 email: inverurieresidential@dmhall.co.uk
Prepared By	DM Hall LLP

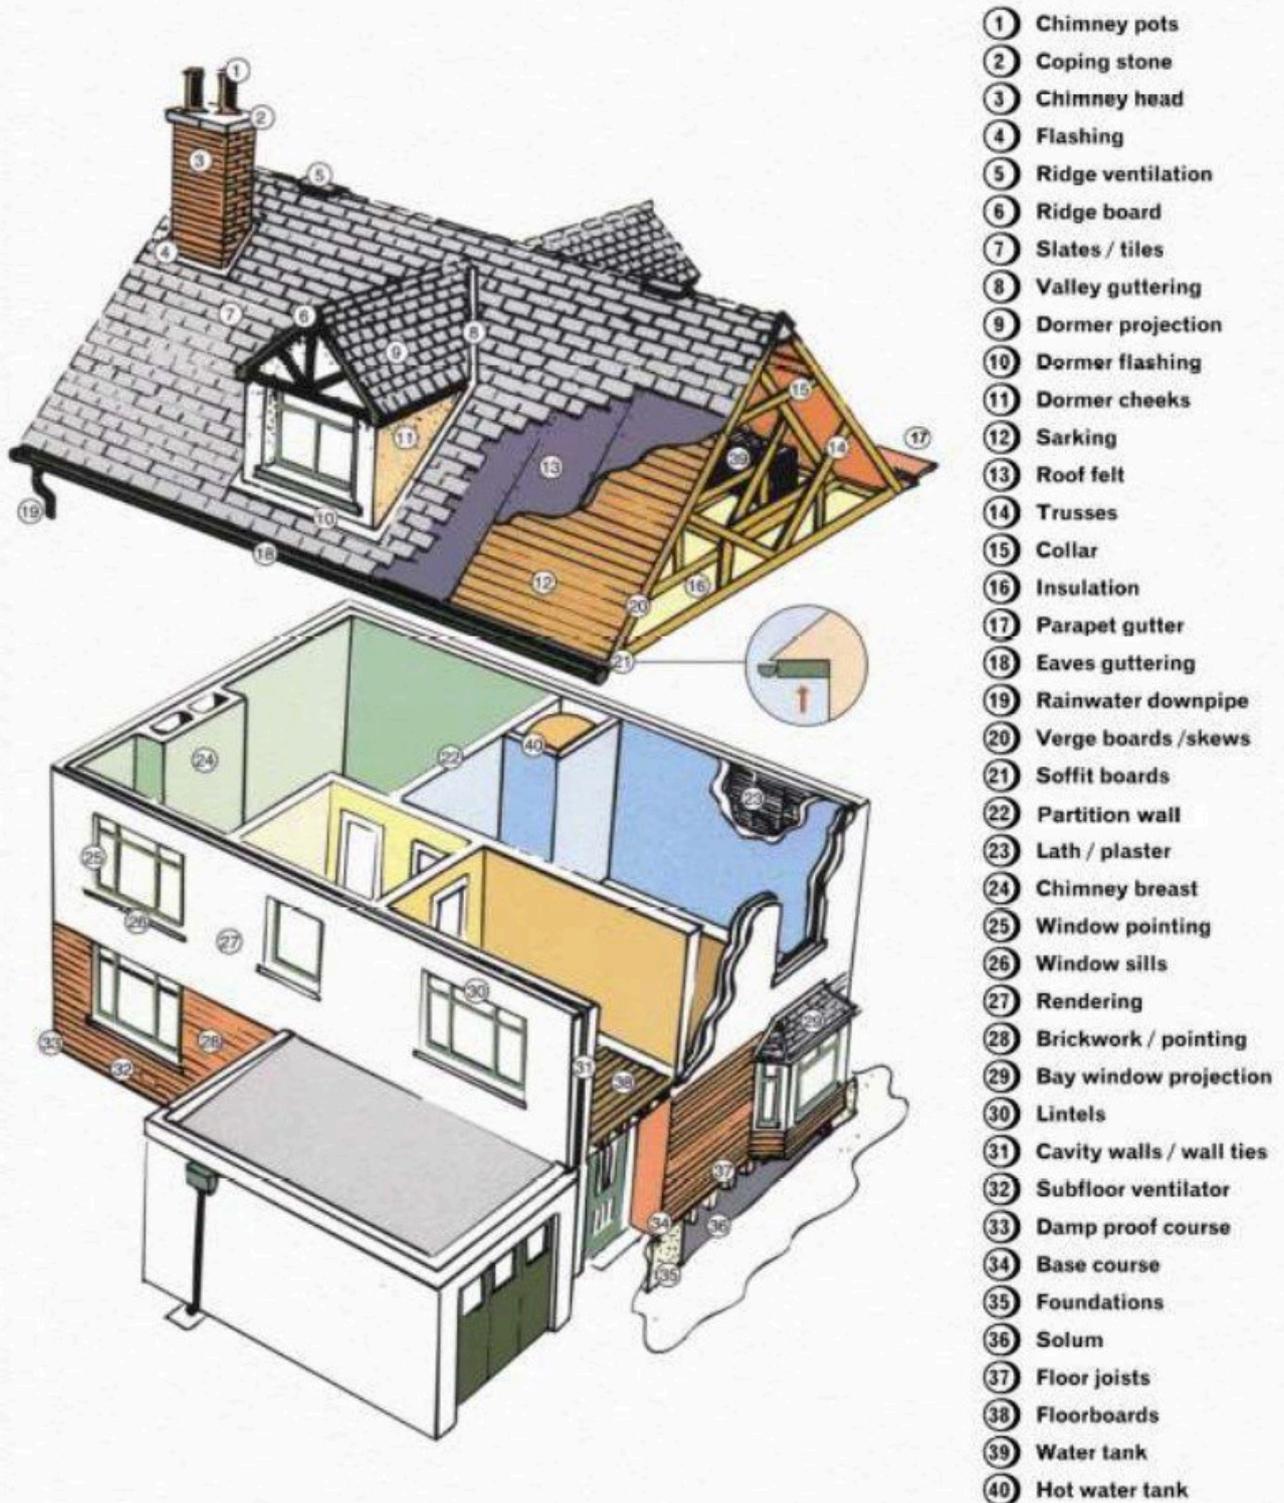
Sectional Diagram showing elements of a typical house

Reference may be made in this report to some or all of the above component parts of the property. This diagram may assist you in locating and understanding these items.

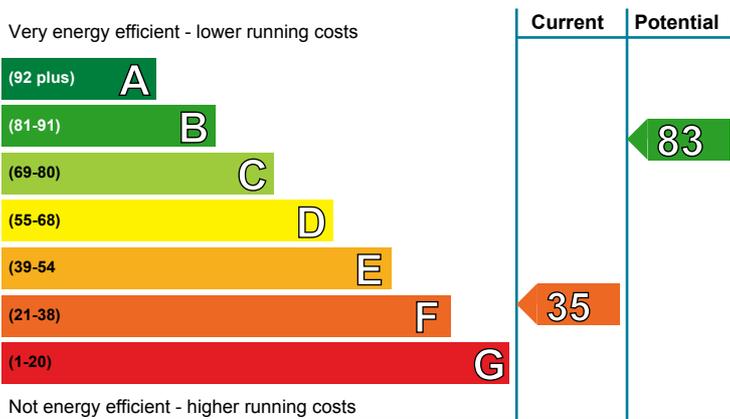
Energy Efficiency Rating

This graph shows the current efficiency of your home, taking into account both energy efficiency and fuel costs. The higher this rating, the lower your fuel bills are likely to be.

Your current rating is **band F (35)**. The average rating for EPCs in Scotland is **band D (61)**.

The potential rating shows the effect of undertaking all of the improvement measures listed within your recommendations report.

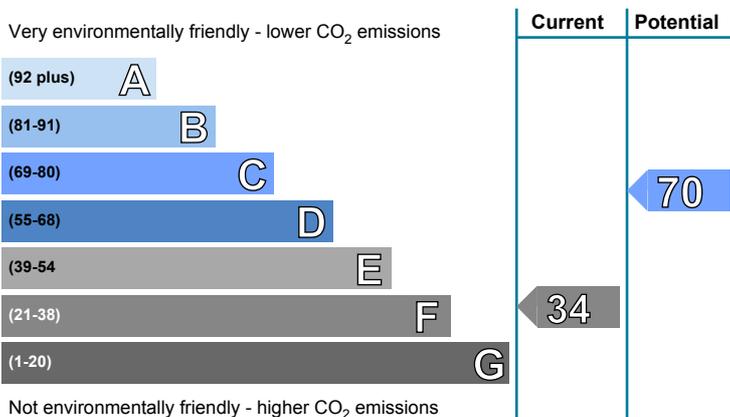
Environmental Impact (CO₂) Rating

This graph shows the effect of your home on the environment in terms of carbon dioxide (CO₂) emissions. The higher the rating, the less impact it has on the environment.
