Home Report

Single Survey

Property address	130 Harbour Road Gardenstown Banff AB45 3YS
Customer	Mr Lee Scarrott
Customer address	130 Harbour Road Gardenstown Banff AB45 3YS
Prepared by	Shepherd Chartered Surveyors
Date of inspection	11/06/2024

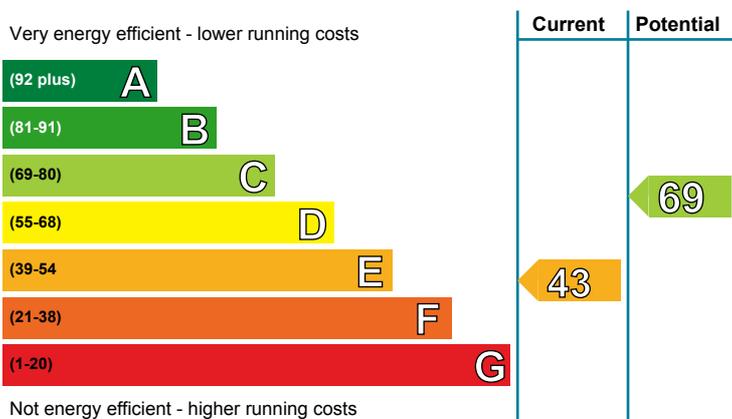
Energy Efficiency Rating

This graph shows the current efficiency of your home, taking into account both energy efficiency and fuel costs. The higher this rating, the lower your fuel bills are likely to be.

Your current rating is **band E (43)**. The average rating for EPCs in Scotland is **band D (61)**.

The potential rating shows the effect of undertaking all of the improvement measures listed within your recommendations report.

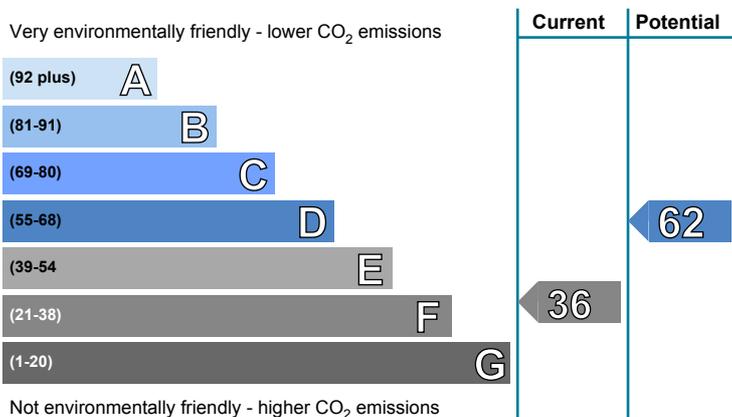
Environmental Impact (CO₂) Rating

This graph shows the effect of your home on the environment in terms of carbon dioxide (CO₂) emissions. The higher the rating, the less impact it has on the environment.
