Home Report

Scottish Single Survey

Property address	1 Boyne Place Whitehills Banff AB45 2GD
Customer	Mrs Solloway
Customer address	1 Boyne Place Whitehills Banff AB45 2GD
Prepared by	Shepherd Chartered Surveyors
Date of inspection	27/04/2026

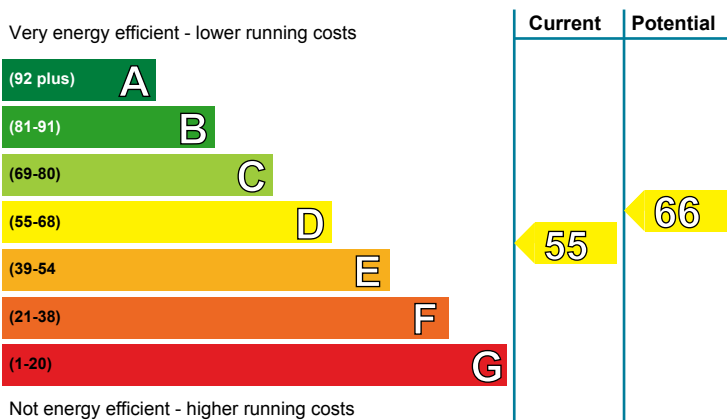
Energy Efficiency Rating

This graph shows the current efficiency of your home, taking into account both energy efficiency and fuel costs. The higher this rating, the lower your fuel bills are likely to be.

Your current rating is **band D (55)**. The average rating for EPCs in Scotland is **band D (61)**.

The potential rating shows the effect of undertaking all of the improvement measures listed within your recommendations report.
