Home Report

Single Survey

Property Address	1 Tillynaught Cottages, Portsoy, Banff, Banffshire, AB45 2YR
Reference	LG202510-40685
Customer Name	Ms Tanya Betts
Date of Inspection	16th October 2025
Surveyor's name, qualifications and office	David Cruickshank DM Hall LLP Chartered Surveyors 27 High Street Elgin IV30 1EE Tel: 01343 548501 email: elginresidential@dmhall.co.uk
Prepared By	DM Hall LLP

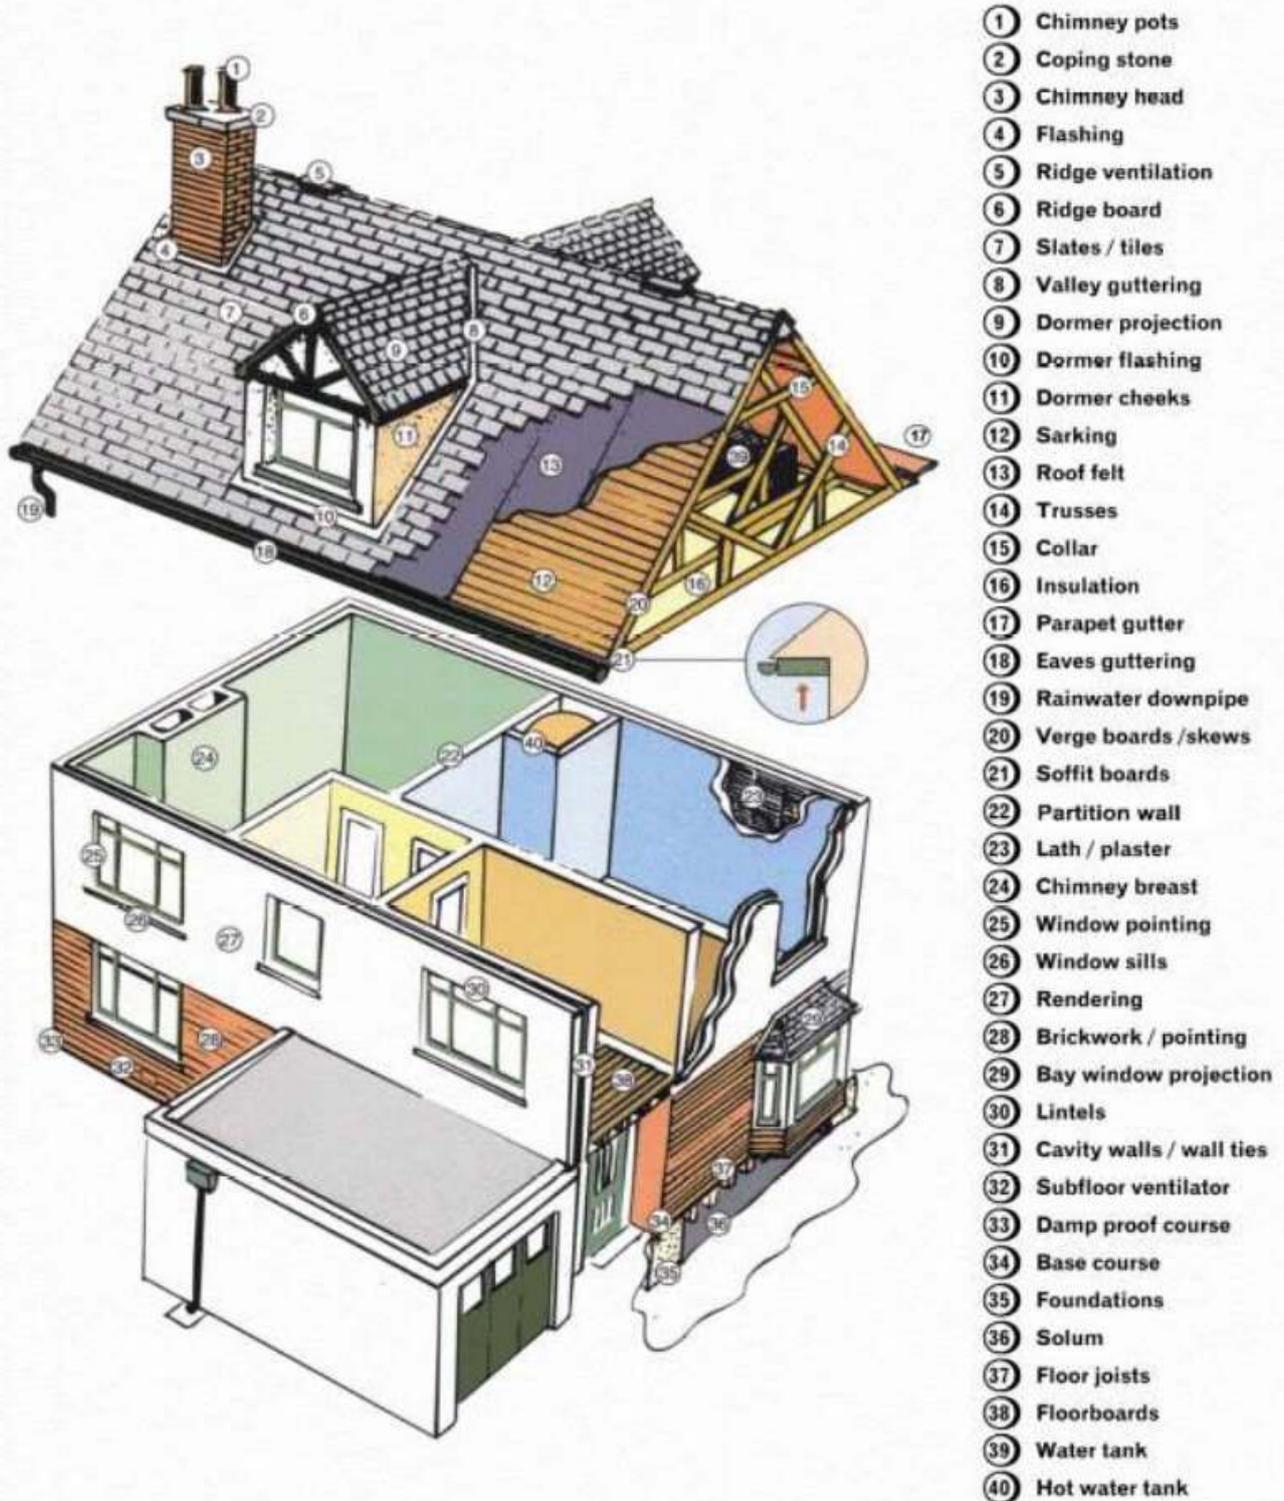
Sectional Diagram showing elements of a typical house

Reference may be made in this report to some or all of the above component parts of the property. This diagram may assist you in locating and understanding these items.

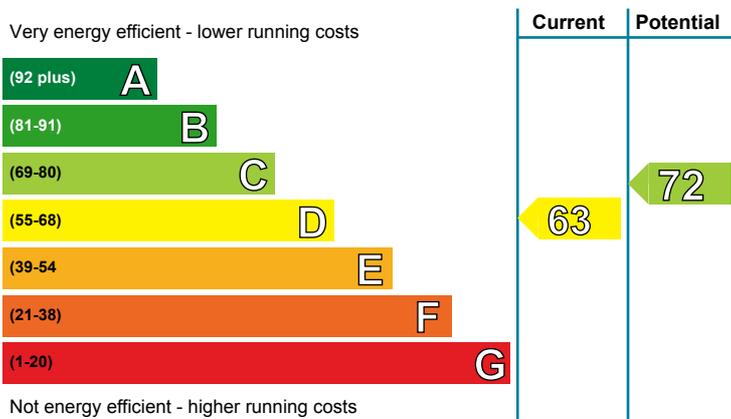
Energy Efficiency Rating

This graph shows the current efficiency of your home, taking into account both energy efficiency and fuel costs. The higher this rating, the lower your fuel bills are likely to be.

Your current rating is **band D (63)**. The average rating for EPCs in Scotland is **band D (61)**.

The potential rating shows the effect of undertaking all of the improvement measures listed within your recommendations report.

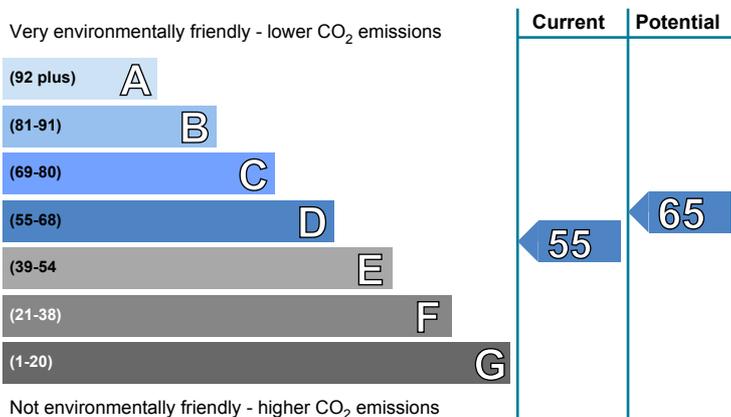
Environmental Impact (CO₂) Rating

This graph shows the effect of your home on the environment in terms of carbon dioxide (CO₂) emissions. The higher the rating, the less impact it has on the environment.
