# Home Report

# Single Survey

<b>Property address</b>	5 Lyndon Court Skene Street Macduff AB44 1QE
<b>Customer</b>	Mr Douglas Reid
<b>Customer address</b>	5 Lyndon Court Skene Street Macduff AB44 1QE
<b>Prepared by</b>	Shepherd Chartered Surveyors
<b>Date of inspection</b>	08/01/2026

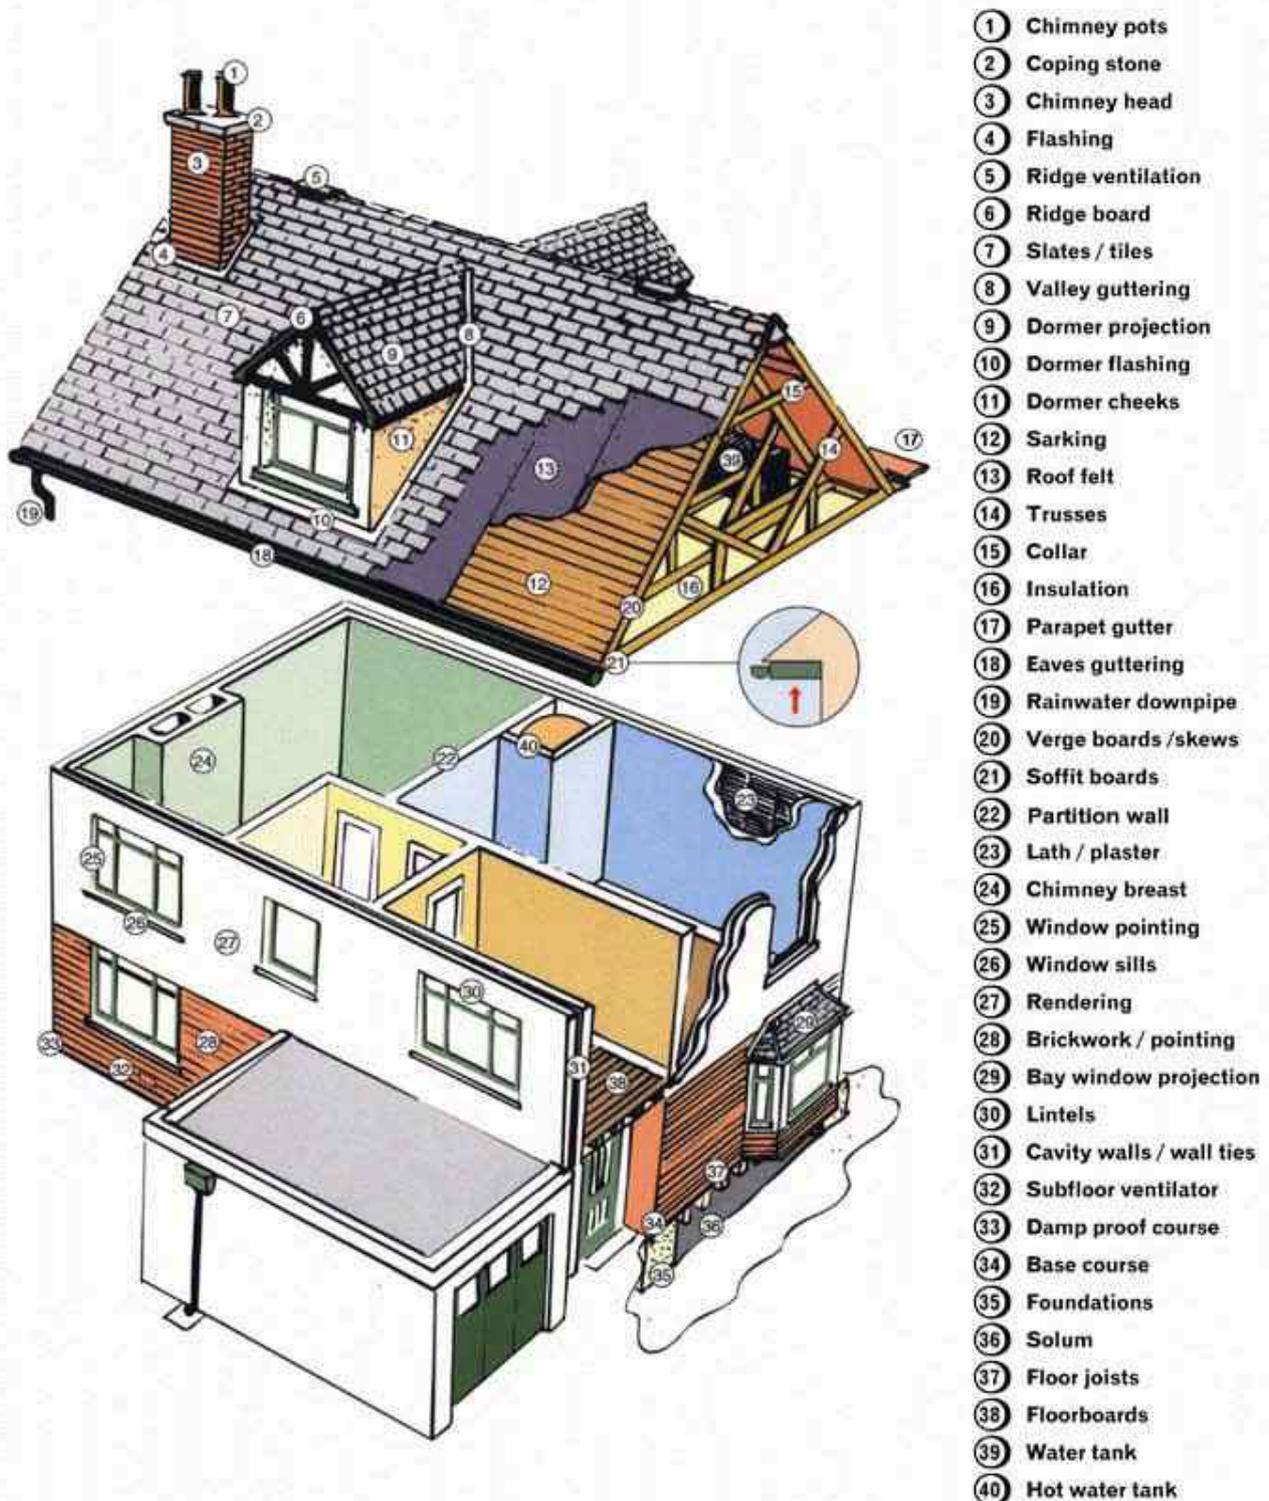
## Sectional Diagram showing elements of a typical house

Reference may be made in this report to some or all of the above component parts of the property. This diagram may assist you in locating and understanding these items.

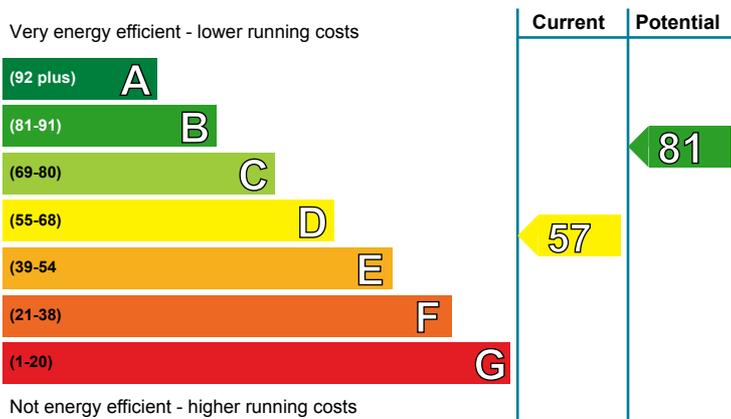
## Energy Efficiency Rating

This graph shows the current efficiency of your home, taking into account both energy efficiency and fuel costs. The higher this rating, the lower your fuel bills are likely to be.

Your current rating is **band D (57)**. The average rating for EPCs in Scotland is **band D (61)**.

The potential rating shows the effect of undertaking all of the improvement measures listed within your recommendations report.

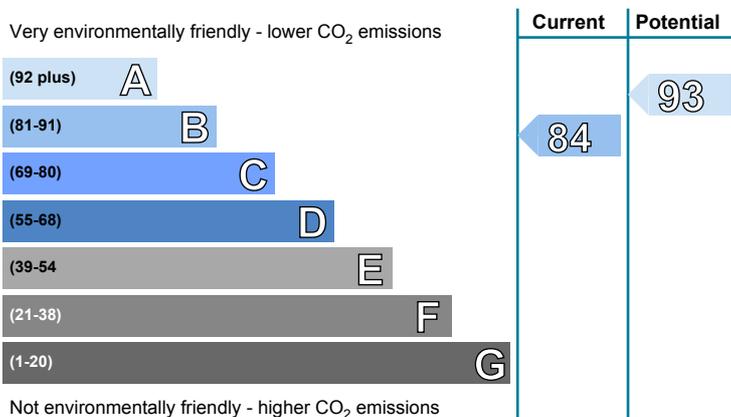
## Environmental Impact (CO<sub>2</sub>) Rating

This graph shows the effect of your home on the environment in terms of carbon dioxide (CO<sub>2</sub>) emissions. The higher the rating, the less impact it has on the environment.
