40 Crown Street,  
Portgordon,  
AB56 5RD

# Home Report

# Single Survey

## Survey Report on:

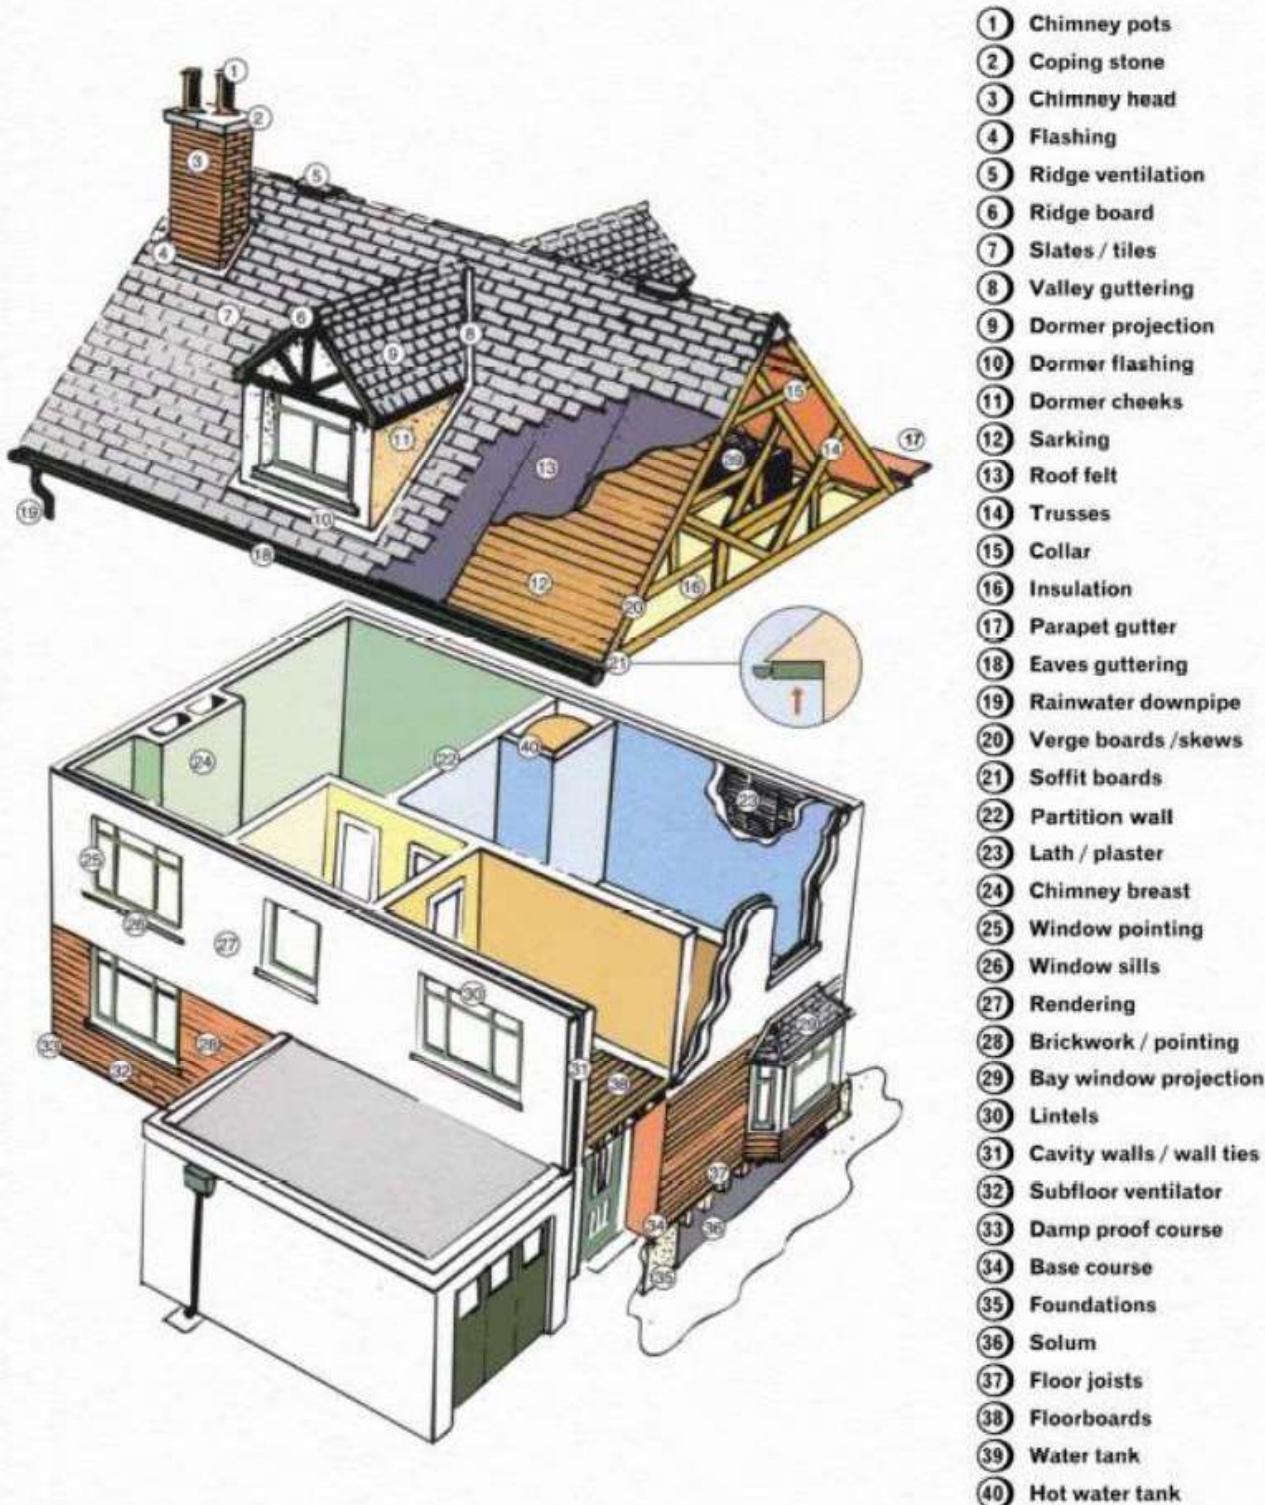
## Sectional Diagram showing elements of a typical house

Reference may be made in this report to some or all of the above component parts of the property. This diagram may assist you in locating and understanding these items.

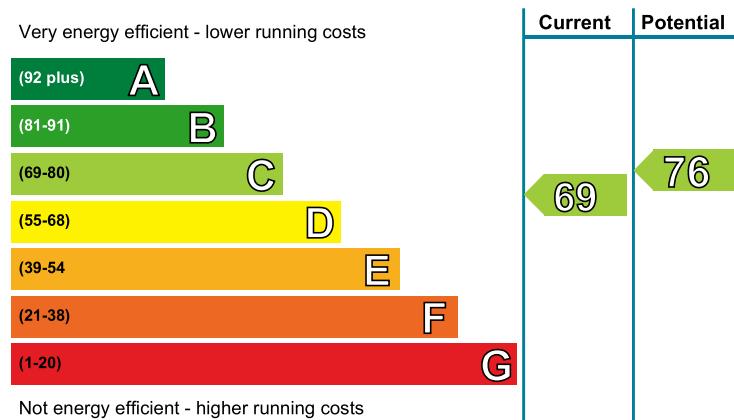
## Energy Efficiency Rating

This graph shows the current efficiency of your home, taking into account both energy efficiency and fuel costs. The higher this rating, the lower your fuel bills are likely to be.

Your current rating is **band C (69)**. The average rating for EPCs in Scotland is **band D (61)**.

The potential rating shows the effect of undertaking all of the improvement measures listed within your recommendations report.

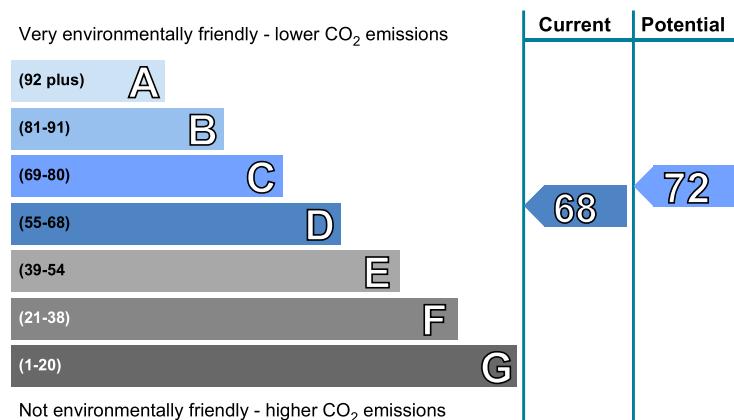
## Environmental Impact (CO<sub>2</sub>) Rating

This graph shows the effect of your home on the environment in terms of carbon dioxide (CO<sub>2</sub>) emissions. The higher the rating, the less impact it has on the environment.
