6a Duke Lane,
Portgordon,
Buckie,
Banffshire,
AB56 5RF

Home Report

Single Survey

Property Address	6a Duke Lane, Portgordon, Buckie, Banffshire, AB56 5RF
Reference	1343912
Customer Name	Anne Cowie's Executry
Date of Inspection	4th December 2025
Surveyor's name, qualifications and office	Stuart McDonald DM Hall LLP Chartered Surveyors 27 High Street Elgin IV30 1EE Tel: 01343 548501 email: elginresidential@dmhall.co.uk
Prepared By	DM Hall LLP

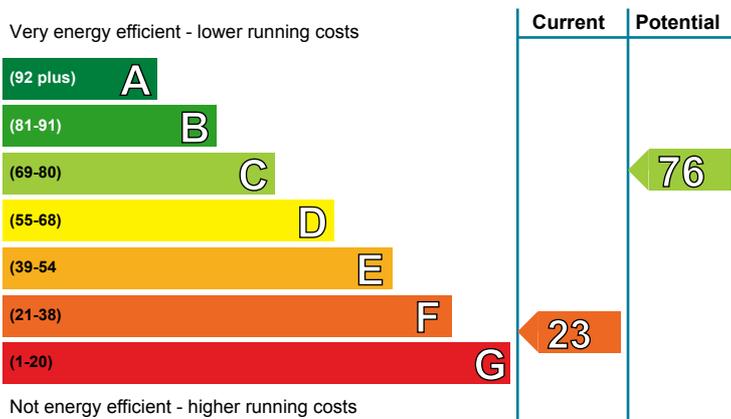
Energy Efficiency Rating

This graph shows the current efficiency of your home, taking into account both energy efficiency and fuel costs. The higher this rating, the lower your fuel bills are likely to be.

Your current rating is **band F (23)**. The average rating for EPCs in Scotland is **band D (61)**.

The potential rating shows the effect of undertaking all of the improvement measures listed within your recommendations report.

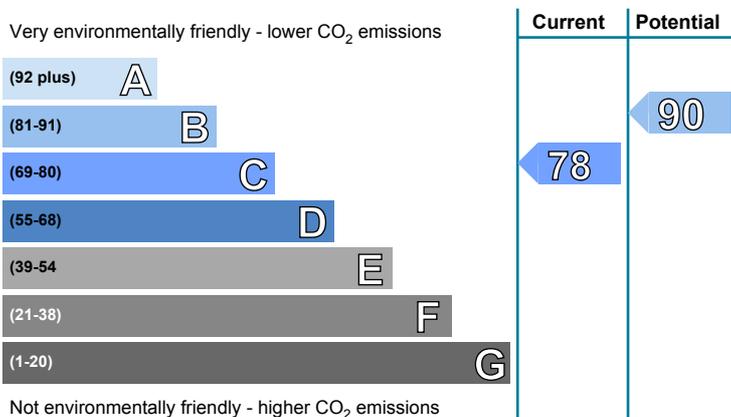
Environmental Impact (CO₂) Rating

This graph shows the effect of your home on the environment in terms of carbon dioxide (CO₂) emissions. The higher the rating, the less impact it has on the environment.
