# Home Report

79 Seatown,  
Buckie,  
Banffshire,  
AB56 1JS

<b>Property Address</b>	79 Seatown, Buckie, Banffshire, AB56 1JS
<b>Reference</b>	1119870
<b>Customer Name</b>	Andrew Young
<b>Date of Inspection</b>	27th June 2025
<b>Surveyor's name, qualifications and office</b>	Stuart McDonald  DM Hall LLP Chartered Surveyors 27 High Street Elgin IV30 1EE  Tel: 01343 548501  email: elginresidential@dmhall.co.uk
<b>Prepared By</b>	DM Hall LLP

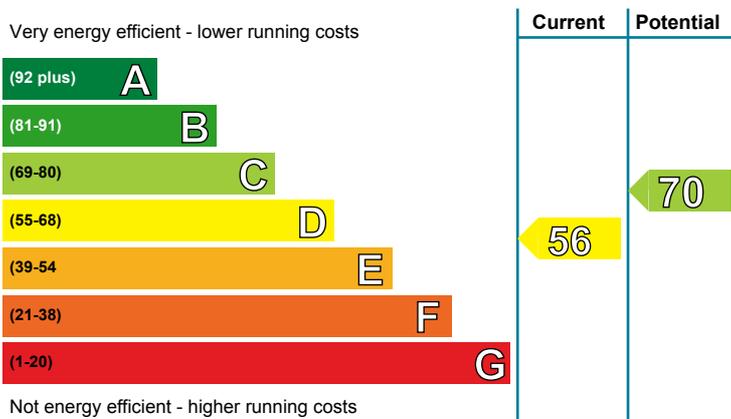
## Energy Efficiency Rating

This graph shows the current efficiency of your home, taking into account both energy efficiency and fuel costs. The higher this rating, the lower your fuel bills are likely to be.

Your current rating is **band D (56)**. The average rating for EPCs in Scotland is **band D (61)**.

The potential rating shows the effect of undertaking all of the improvement measures listed within your recommendations report.

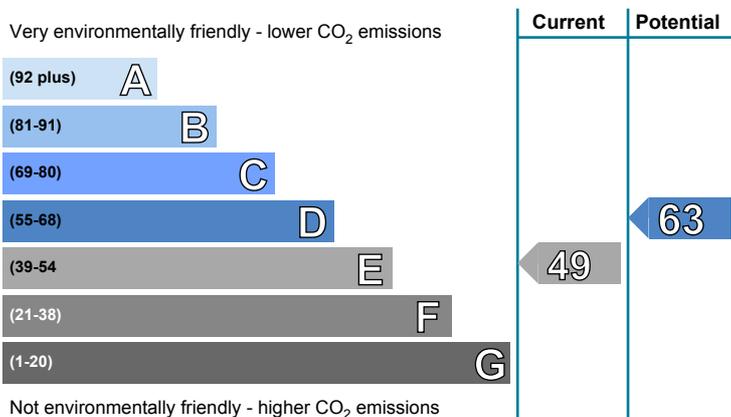
## Environmental Impact (CO<sub>2</sub>) Rating

This graph shows the effect of your home on the environment in terms of carbon dioxide (CO<sub>2</sub>) emissions. The higher the rating, the less impact it has on the environment.
