15 Mairs Street,
Portknockie,
Moray,
AB56 4NL

Home Report

Single Survey

Property Address	15 Mairs Street, Portknockie, Moray, AB56 4NL
Reference	1524210
Customer Name	James Mair
Date of Inspection	23rd April 2026
Surveyor's name, qualifications and office	Stuart McDonald DM Hall LLP Chartered Surveyors 27 High Street Elgin IV30 1EE Tel: 01343 548501 email: elginresidential@dmhall.co.uk
Prepared By	DM Hall LLP

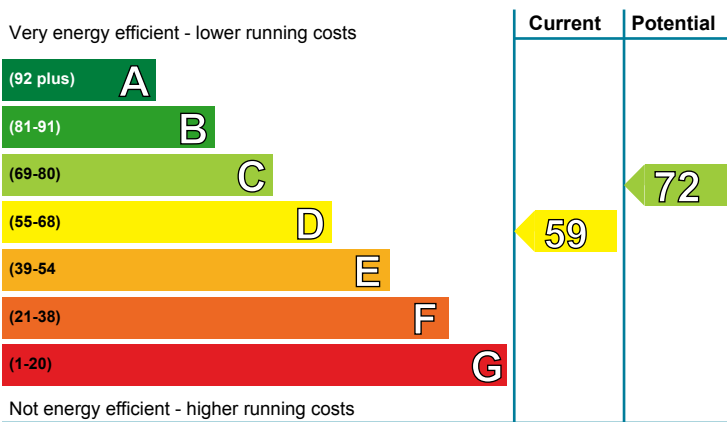
Energy Efficiency Rating

This graph shows the current efficiency of your home, taking into account both energy efficiency and fuel costs. The higher this rating, the lower your fuel bills are likely to be.

Your current rating is **band D (59)**. The average rating for EPCs in Scotland is **band D (61)**.

The potential rating shows the effect of undertaking all of the improvement measures listed within your recommendations report.

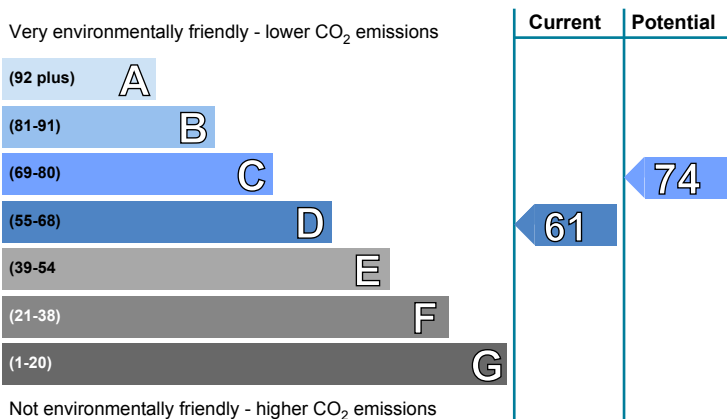
Environmental Impact (CO₂) Rating

This graph shows the effect of your home on the environment in terms of carbon dioxide (CO₂) emissions. The higher the rating, the less impact it has on the environment.
