32 Linn Crescent,
BUCKIE,
AB56 1NA

Home Report

Single Survey

Property Address	32 Linn Crescent, BUCKIE, AB56 1NA
Reference	1526765
Customer Name	Michael Stewart
Date of Inspection	22nd April 2026
Surveyor's name, qualifications and office	Stuart McDonald DM Hall LLP Chartered Surveyors 27 High Street Elgin IV30 1EE Tel: 01343 548501 email: elginresidential@dmhall.co.uk
Prepared By	DM Hall LLP

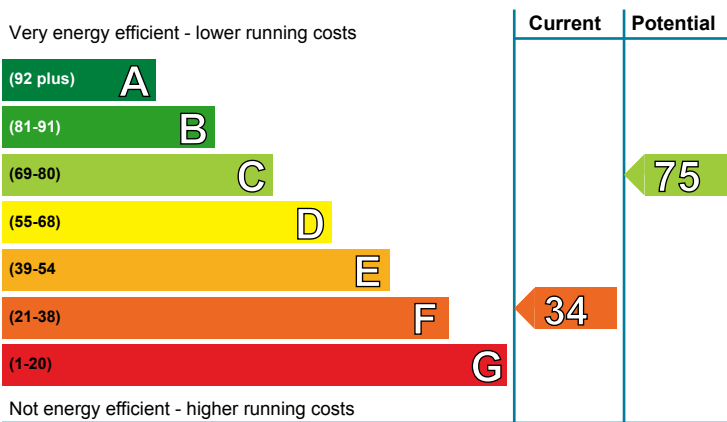
Energy Efficiency Rating

This graph shows the current efficiency of your home, taking into account both energy efficiency and fuel costs. The higher this rating, the lower your fuel bills are likely to be.

Your current rating is **band F (34)**. The average rating for EPCs in Scotland is **band D (61)**.

The potential rating shows the effect of undertaking all of the improvement measures listed within your recommendations report.

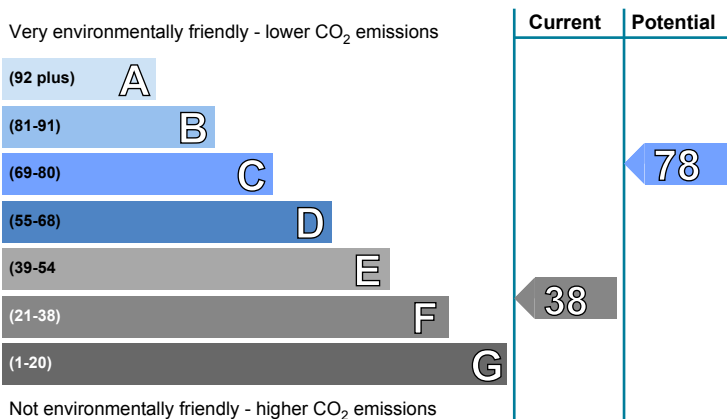
Environmental Impact (CO₂) Rating

This graph shows the effect of your home on the environment in terms of carbon dioxide (CO₂) emissions. The higher the rating, the less impact it has on the environment.
