HOME REPORT

32 VICTORIA GARDENS
BANFF
AB45 2JG

Energy Performance Certificate (EPC)

32 VICTORIA GARDENS, BANFF, AB45 2JG

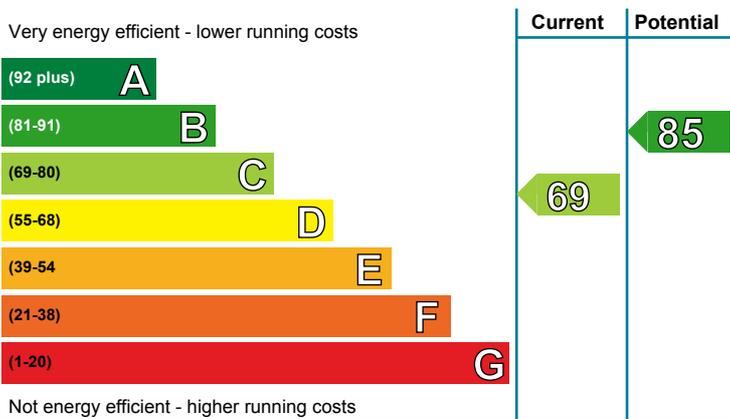
Energy Efficiency Rating

This graph shows the current efficiency of your home, taking into account both energy efficiency and fuel costs. The higher this rating, the lower your fuel bills are likely to be.

Your current rating is **band C (69)**. The average rating for EPCs in Scotland is **band D (61)**.

The potential rating shows the effect of undertaking all of the improvement measures listed within your recommendations report.

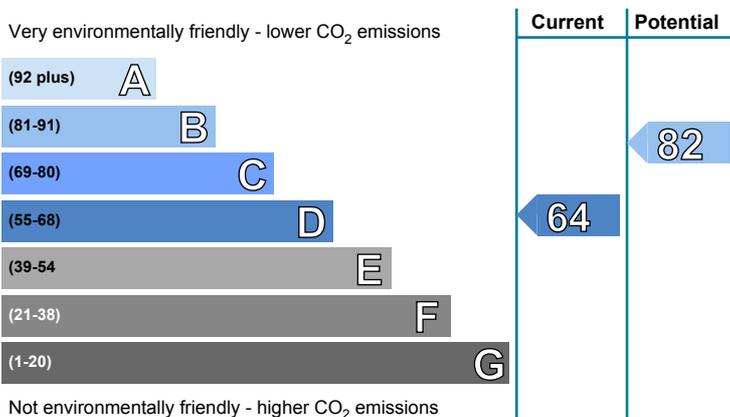
Environmental Impact (CO₂) Rating

This graph shows the effect of your home on the environment in terms of carbon dioxide (CO₂) emissions. The higher the rating, the less impact it has on the environment.

Your current rating is **band D (64)**. The average rating for EPCs in Scotland is **band D (59)**.

The potential rating shows the effect of undertaking all of the improvement measures listed within your recommendations report.
