11 Scotstown,
Banff,
AB45 1LA

Home Report

Single Survey

Property Address	11 Scotstown, Banff, AB45 1LA
Reference	1537200
Customer Name	Scottish Episcopal Church Nominees
Date of Inspection	6th May 2026
Surveyor's name, qualifications and office	Greig Baxter BSc (HONS) MRICS DM Hall LLP Chartered Surveyors 64 Market Place Inverurie AB51 3XN Tel: 01467 624393 email: inverurieresidential@dmhall.co.uk
Prepared By	DM Hall LLP

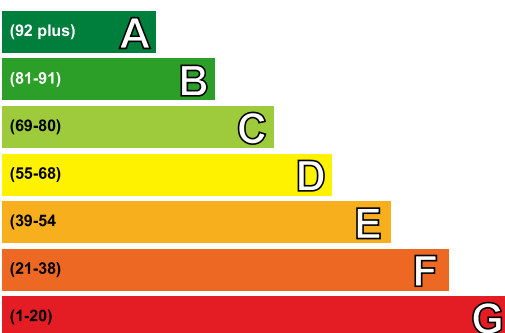
Energy Efficiency Rating

Very energy efficient - lower running costs

Current	Potential
55	77

Not energy efficient - higher running costs
